The Road Inventory of San Bernardino National Wildlife Refuge Douglas, AZ

Prepared By:
Federal Highway Administration
Central Federal Lands Highway Division
March 2008

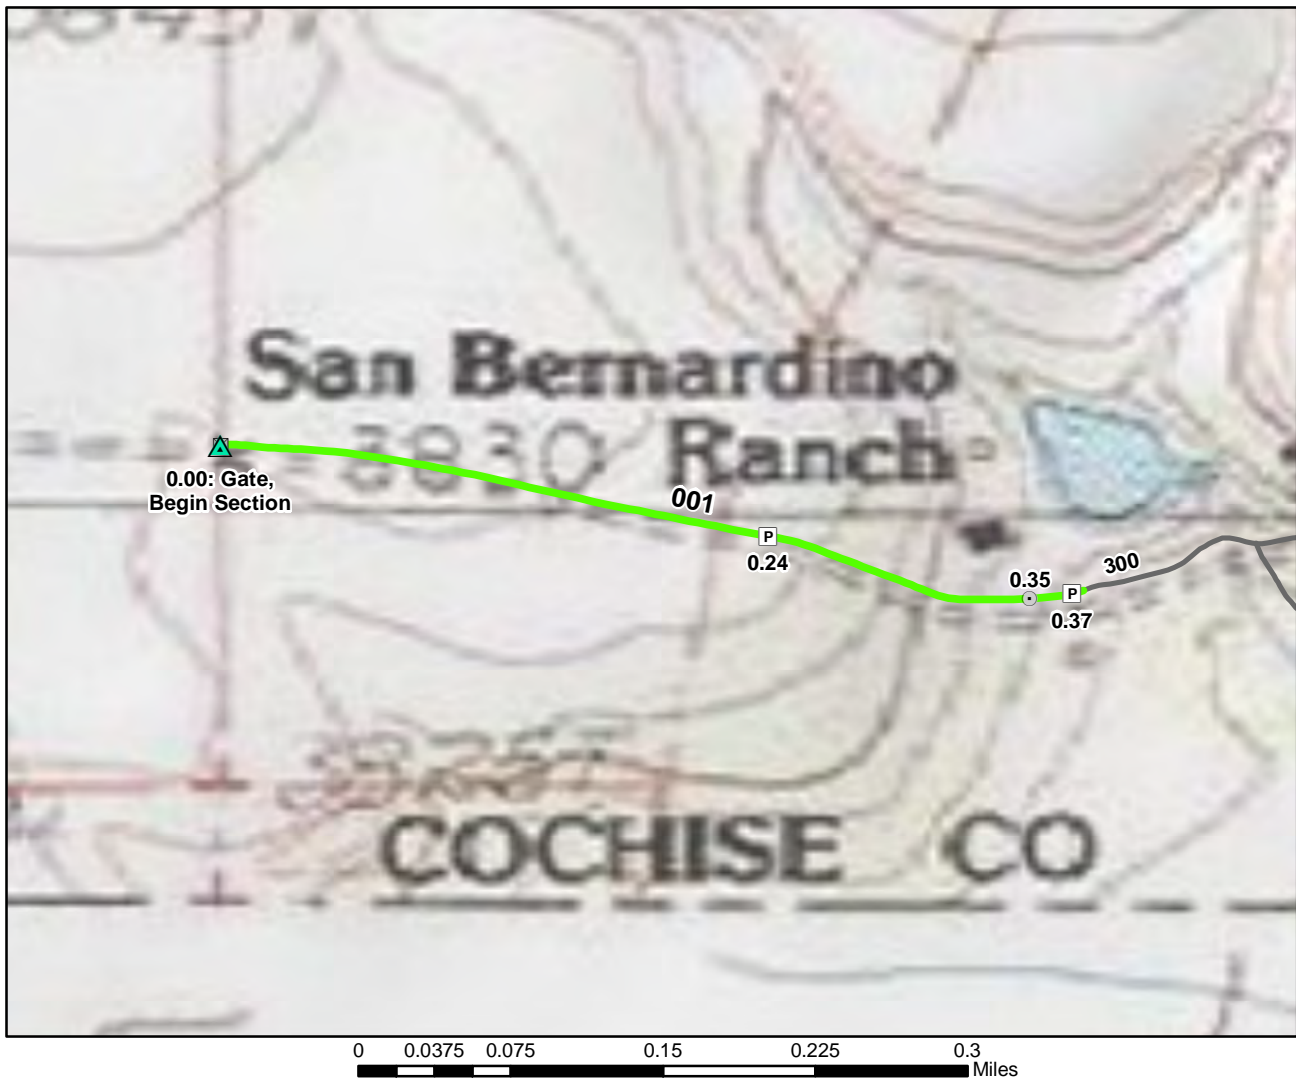
ROUTE: 010 Headquarters Entrance Road

Section Number	001				
Section Length (miles)	1.13				
Inspection Date	3/13/2008				
Section Information					
Surface Type	Asphalt				
Number of Lanes	1				
Roadway Width (feet)	12				
Roadway Condition Information					
Condition	Poor				
Remaining Service Life (years)	6				
Cost Estimate	\$654500				
CRV	\$1328500

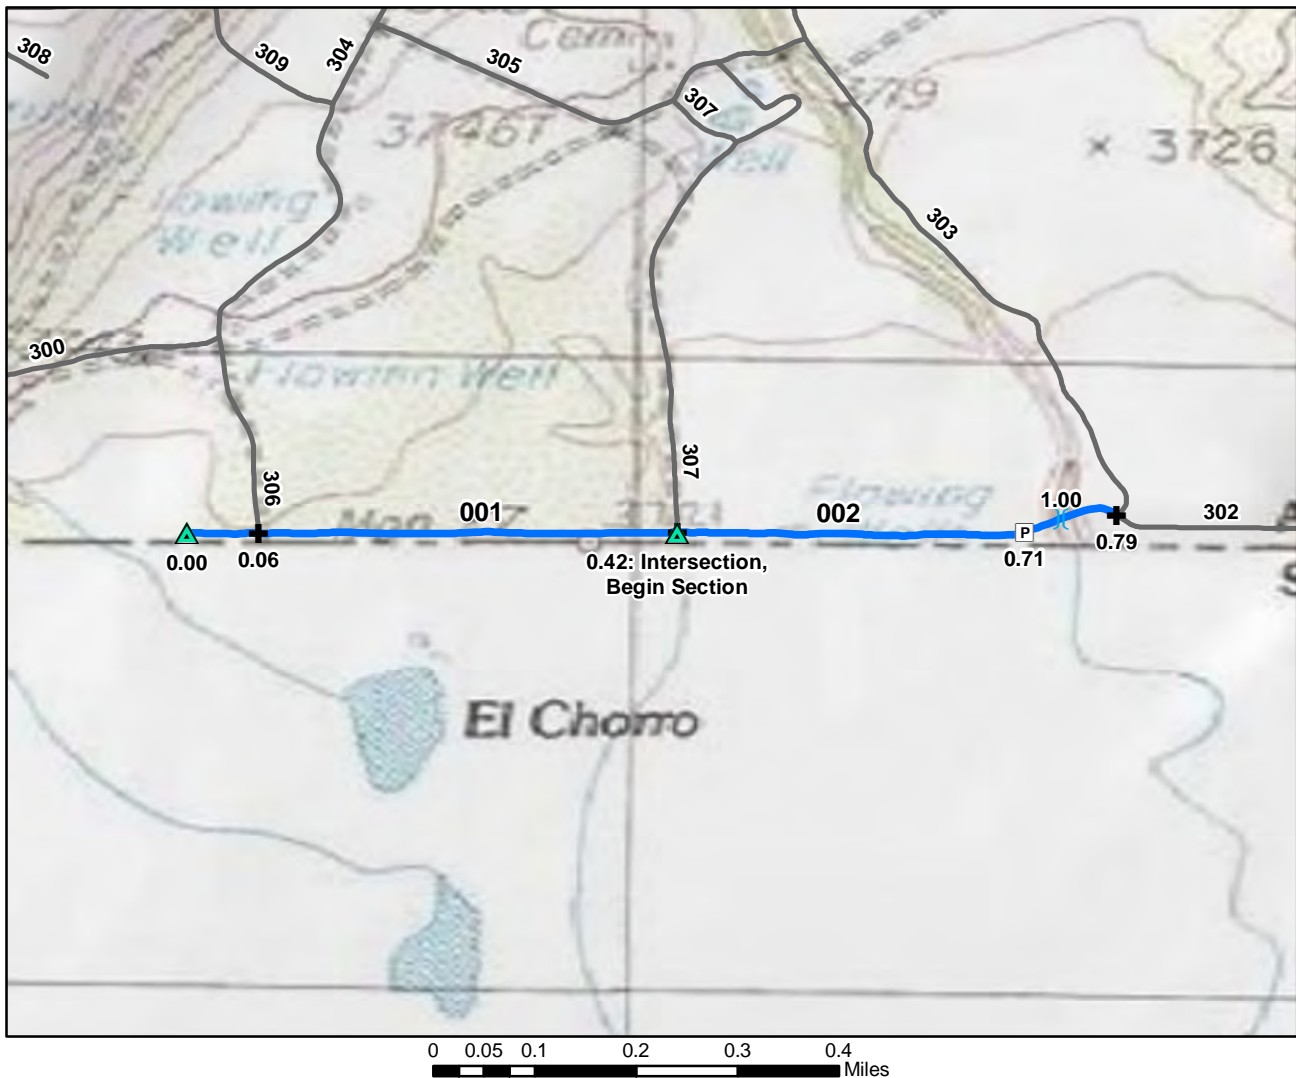
ROUTE: 300 Slaughter Administrative Road TOTAL LENGTH: 0.70 Miles

Section Number	001	002	003		
Section Length (miles)	0.42	0.12	0.15		
Inspection Date	3/13/2008	3/13/2008	3/13/2008		
Section Information					
Surface Type	Native	Native	Gravel		
Number of Lanes	1	1	1		
Roadway Width (feet)	9	9	10		
Roadway Condition Information					
Condition	Excellent	Excellent	Excellent		
Remaining Service Life (years)	9	9	9		
Cost Estimate	\$0	\$0	\$0		
CRV	\$148200	\$42700	\$104600

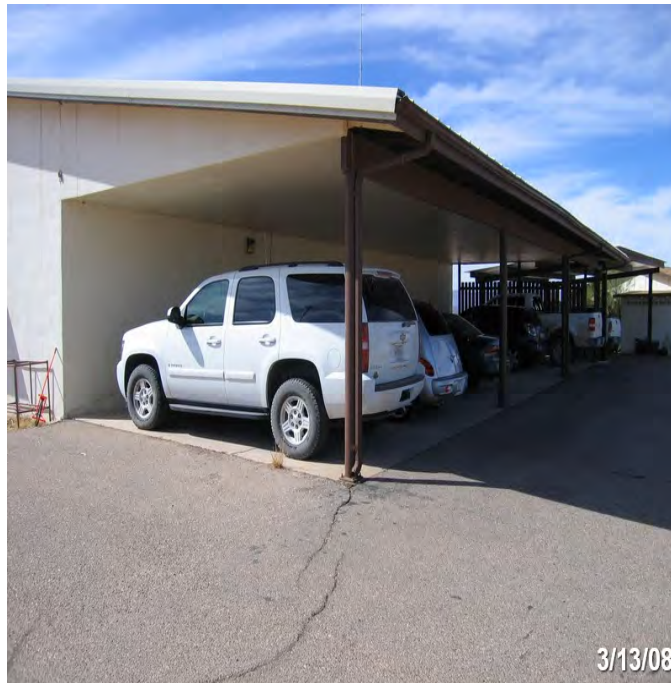
Route 800: Visitor Center Parking #2

Asset Number	Date Visited	Surface Type	Area (sq ft)	Condition	Cost to Improve
	3/13/2008	Concrete	1572	Excellent	\$0

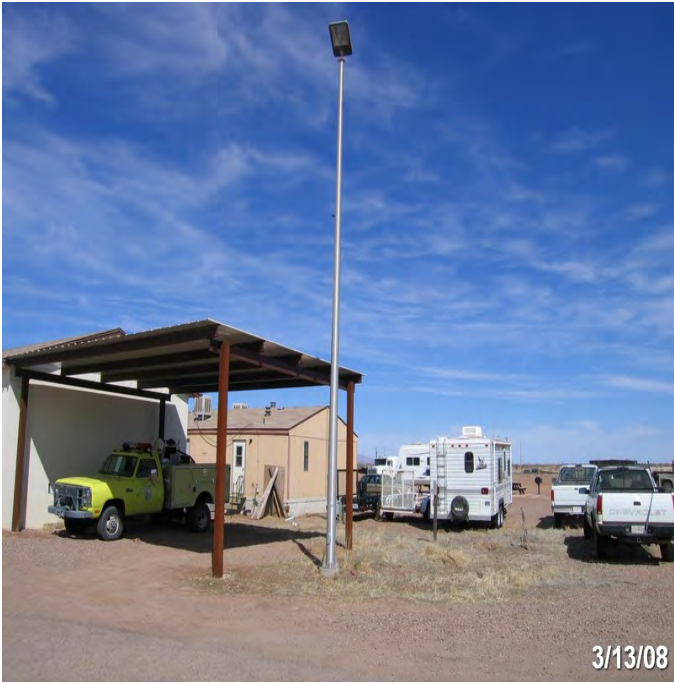
Route 801: Visitor Center Parking #3

Asset Number	Date Visited	Surface Type	Area (sq ft)	Condition	Cost to Improve
	3/13/2008	Native	4073	Good	\$600

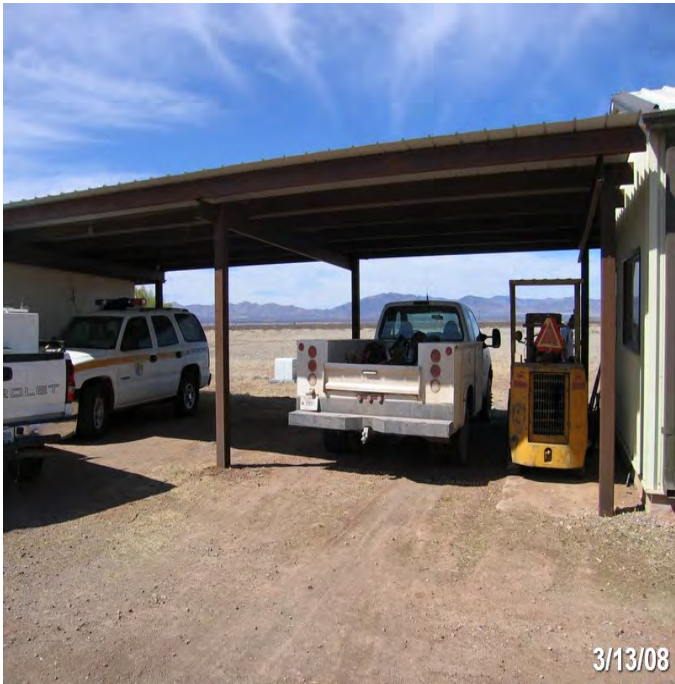
Route 802: Visitor Center Parking #4

Asset Number	Date Visited	Surface Type	Area (sq ft)	Condition	Cost to Improve
	3/13/2008	Gravel	959	Good	\$100

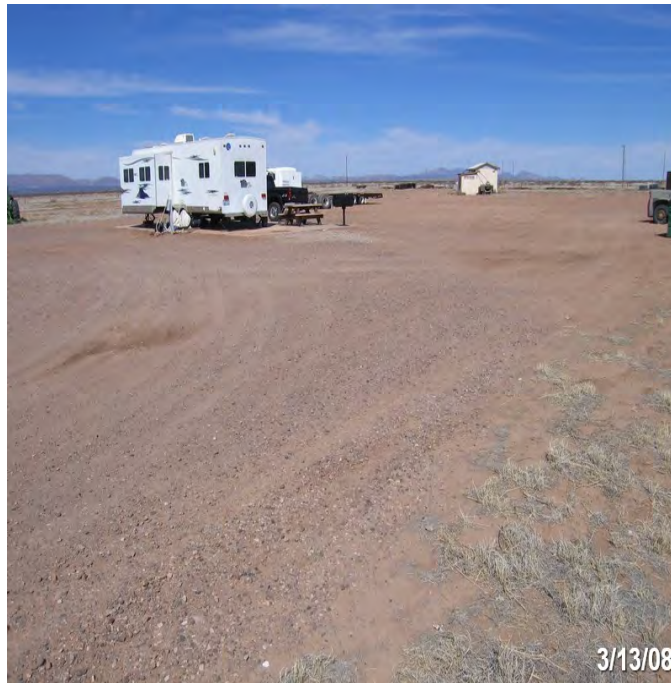
Route 803: Visitor Center Parking #5

Asset Number	Date Visited	Surface Type	Area (sq ft)	Condition	Cost to Improve
	3/13/2008	Native	38516	Good	\$5700

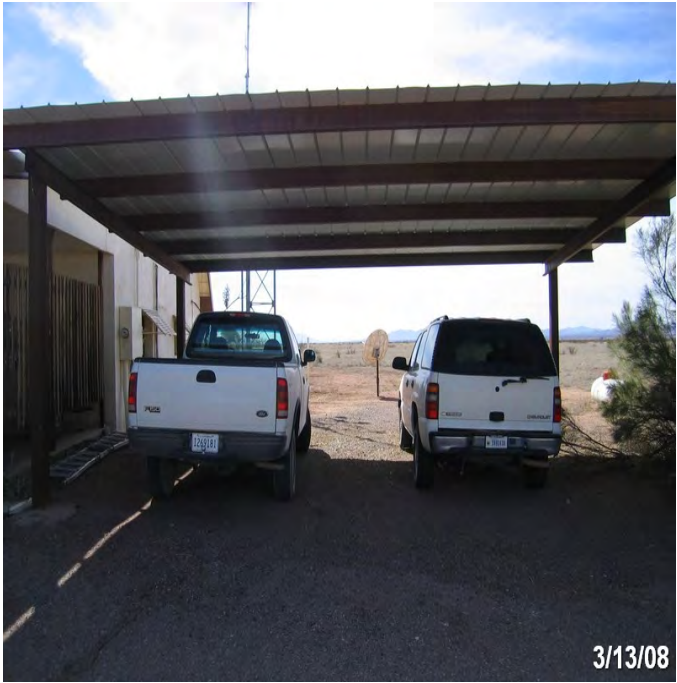
Route 804: Visitor Center Parking #6

Asset Number	Date Visited	Surface Type	Area (sq ft)	Condition	Cost to Improve
	3/13/2008	Gravel	635	Poor	\$700

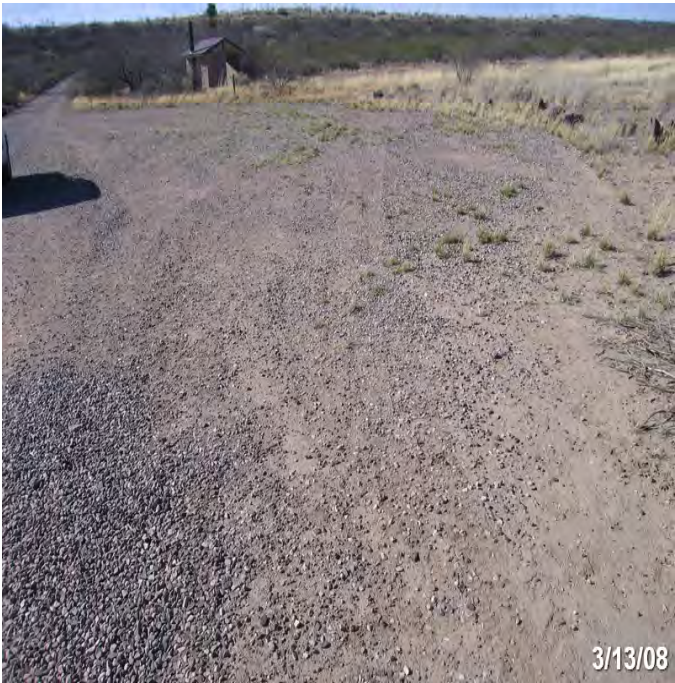
Route 805: Restroom Parking

Asset Number	Date Visited	Surface Type	Area (sq ft)	Condition	Cost to Improve
10038313	3/13/2008	Gravel	3376	Poor	\$3700

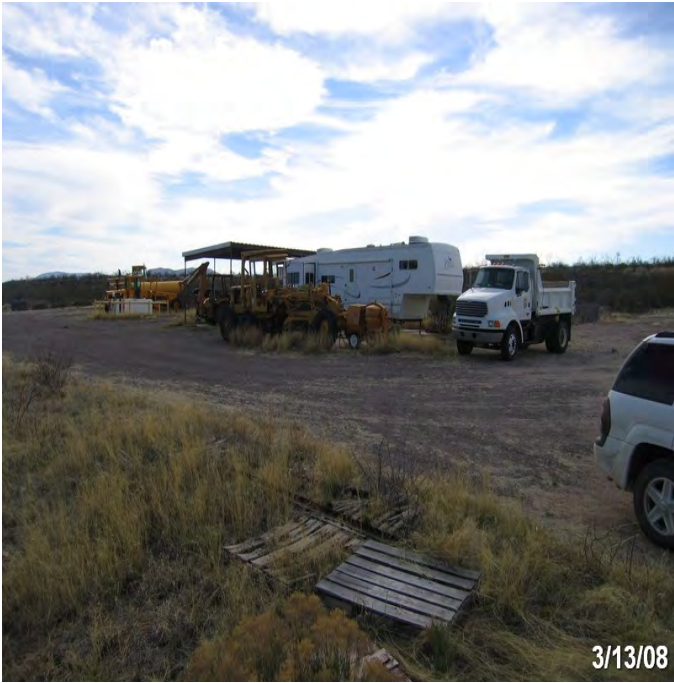
Route 806: Shop Parking #1

Asset Number	Date Visited	Surface Type	Area (sq ft)	Condition	Cost to Improve
	3/13/2008	Native	18963	Good	\$2800

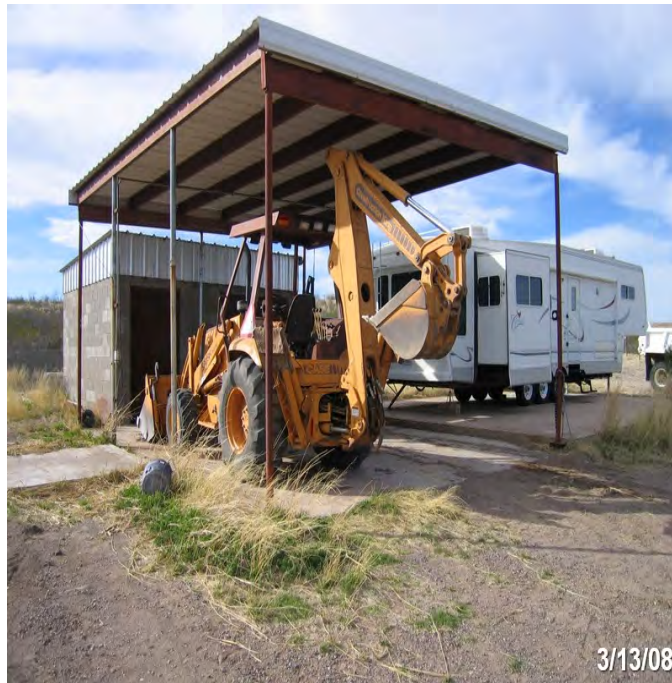
Route 807: Shop Parking #2

Asset Number	Date Visited	Surface Type	Area (sq ft)	Condition	Cost to Improve
	3/13/2008	Concrete	2684	Good	\$400

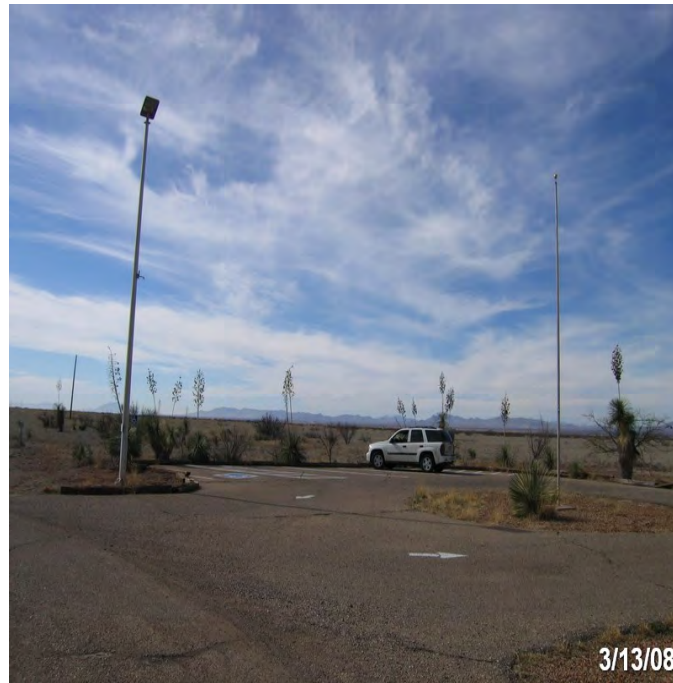
Route 900: Visitor Center Parking #1

Asset Number	Date Visited	Surface Type	Area (sq ft)	Condition	Cost to Improve
10038304	3/13/2008	Asphalt	4809	Poor	\$22700

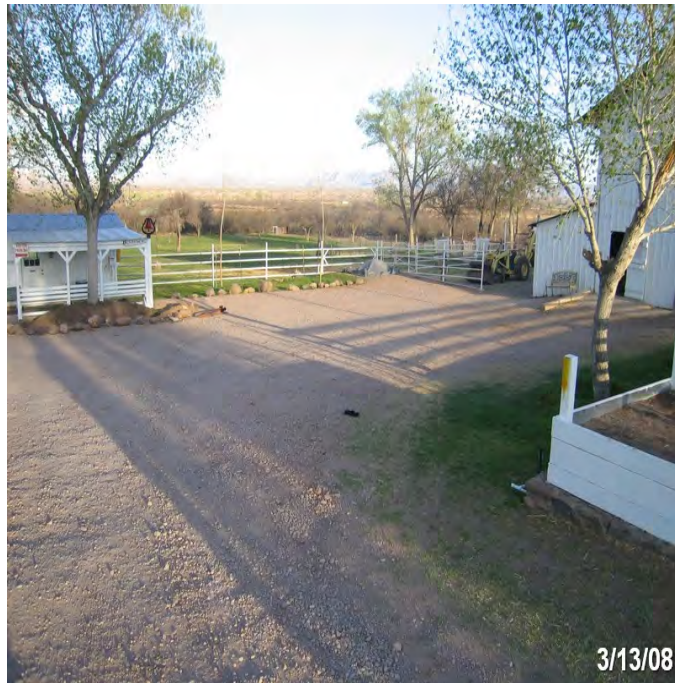
Route 901: Visitor Parking

Asset Number	Date Visited	Surface Type	Area (sq ft)	Condition	Cost to Improve
	3/13/2008	Gravel	3570	Excellent	\$0

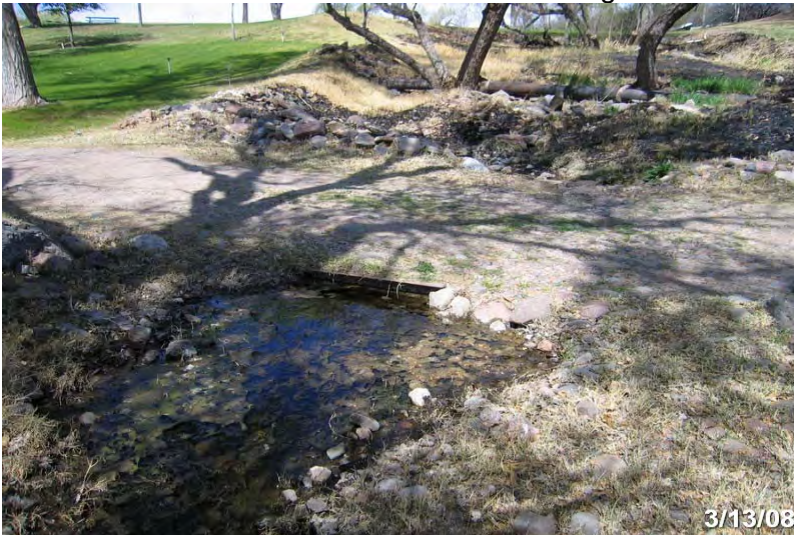
Photo # 2687 - MP 0.07 - Bridge

San Bernardino NWR Bridge Inventory					
Rte #	Milepost	NBIS #	Sufficiency Rating	Functionally Obsolete	Structurally Deficient
300	0.07	N/A	N/A	N/A	N/A
